Site investigation and modelling at “La Maina” landslide (Carnian Alps, Italy)

G. Marcato¹, M. Mantovani¹, A. Pasuto², S. Silvano¹, F. Tagliavini², L. Zabuski³, and A. Zannoni¹

Abstract. The Sauris reservoir is a hydroelectric basin closed downstream by a 136 m high, double arc concrete dam. The dam is firmly anchored to a consistent rock (Dolomia dello Schlern), but the Lower Triassic clayey formations, cropping out especially in the lower part of the slopes, have made the whole catchment basin increasingly prone to landslides. In recent years, the “La Maina landslide” has opened up several joints over a surface of about 100 000 m², displacing about 1 500 000 m³ of material. Particular attention is now being given to the evolution of the instability area, as the reservoir is located at the foot of the landslide. Under the commission of the Regional Authority for Civil Protection a numerical modelling simulation in a pseudo-time condition of the slope was developed, in order to understand the risk for transport infrastructures, for some houses and for the reservoir and to take urgent measures to stabilize the slope. A monitoring system consisting of four inclinometers, three wire

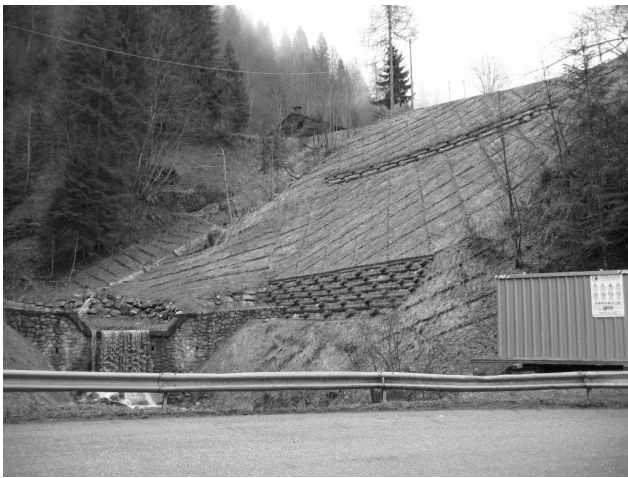
Fig. 8. Lower part of the “La Maina” landslide after the consolidation.

The high risk caused by “La Maina” landslide forced a type of investigation that could provide reliable results in short time. The monitoring system was important both to evaluate the hazard of the landslide and to collect data for the model. The survey and modelling allowed to recognize that at present there are two distinct landslide’s bodies. Since an increasing of the water table seems to be unreasonable with the data collected, a sudden failure of the slope is not expected. The good agreement between the model and the geological and morphological evidences outlined the proper mitigation measures. The urgent consolidation was focused on the lower part of the landslide where the elements at risk are located. Using naturalistic engineering the Corpo Forestale dello Stato has installed a system of superficial drainage and has consolidated the slope in order to avoid the erosion by the Poch stream (Fig. 8). For the upper body of the landslide a complex drainage system is planned for the future.
